1. Report No. FHWA/TX-04/0-4434-1		2. Government Accession No.		3. Recipient's Catalog No.	
4. Title and Subtitle CRASH ANALYSIS OF SELECTED HIGH-OCCUPANCY VEHICLE FACILITIES IN TEXAS: METHODOLOGY, FINDINGS, AND RECOMMENDATIONS				5. Report Date September 2003 Resubmitted: May 2004

**CRASH ANALYSIS OF SELECTED HIGH-OCCUPANCY VEHICLE
FACILITIES IN TEXAS: METHODOLOGY, FINDINGS, AND
RECOMMENDATIONS**

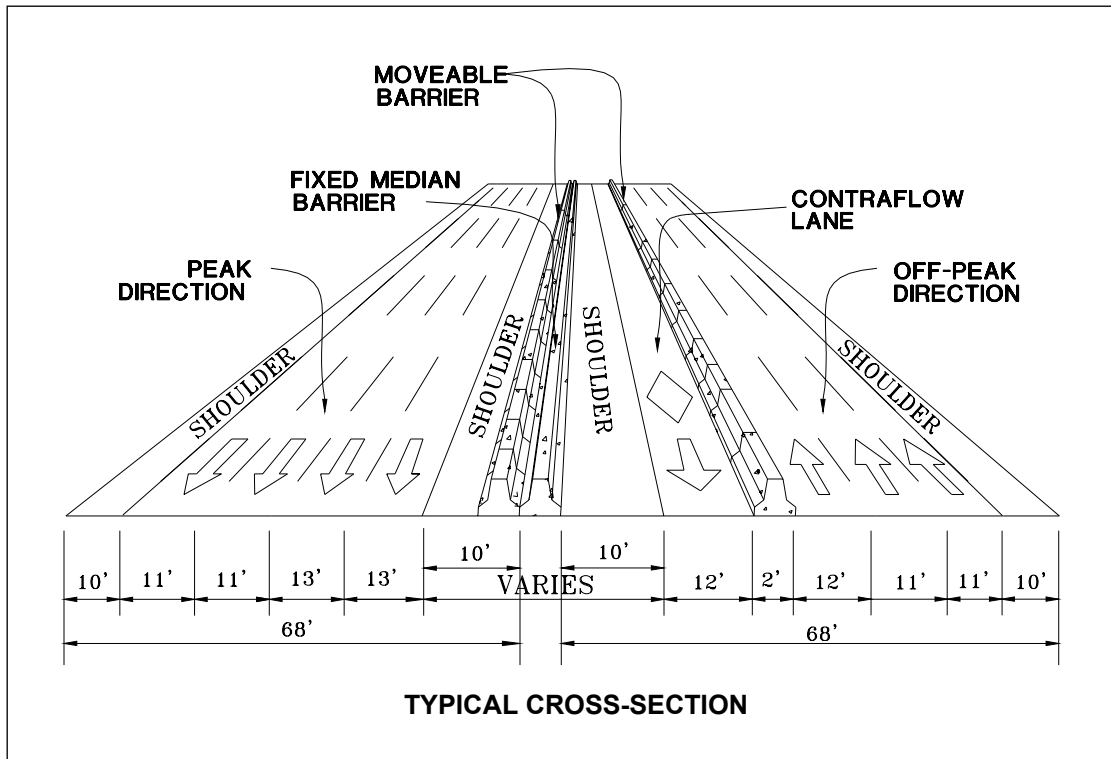
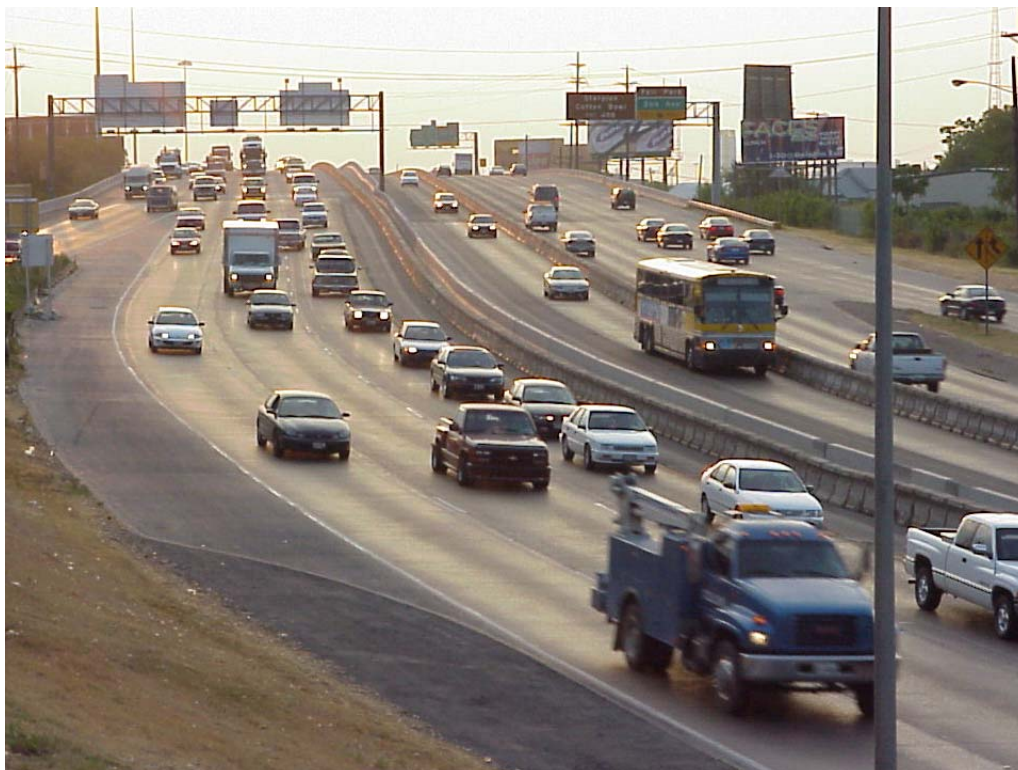
Figure 1. IH-30 (ERLT) Contraflow HOV Lane (Dallas, Texas).

Figures 1, 2, and 3 show the typical cross-sections for IH-30 (East R.L. Thornton Freeway), IH-35E North (Stemmons Freeway), and IH-635 (LBJ Freeway), respectively. Each cross-section is followed by a table (Tables 3-5) showing yearly crash rates for the particular corridor. Year 2000 crash data were the most recent data available from the DPS database at the time of this research.

Table 3 shows higher corridor crash rates between the years 1994-1996. Several major construction projects in the corridor would seem to explain this increase, as the crash rates declined in subsequent years. The injury crash rates prior to implementation of the HOV lane, with the exception of 1990, are generally similar to the crash rates after implementation. The research team could not determine the reason for the low injury crash rate in 1990.

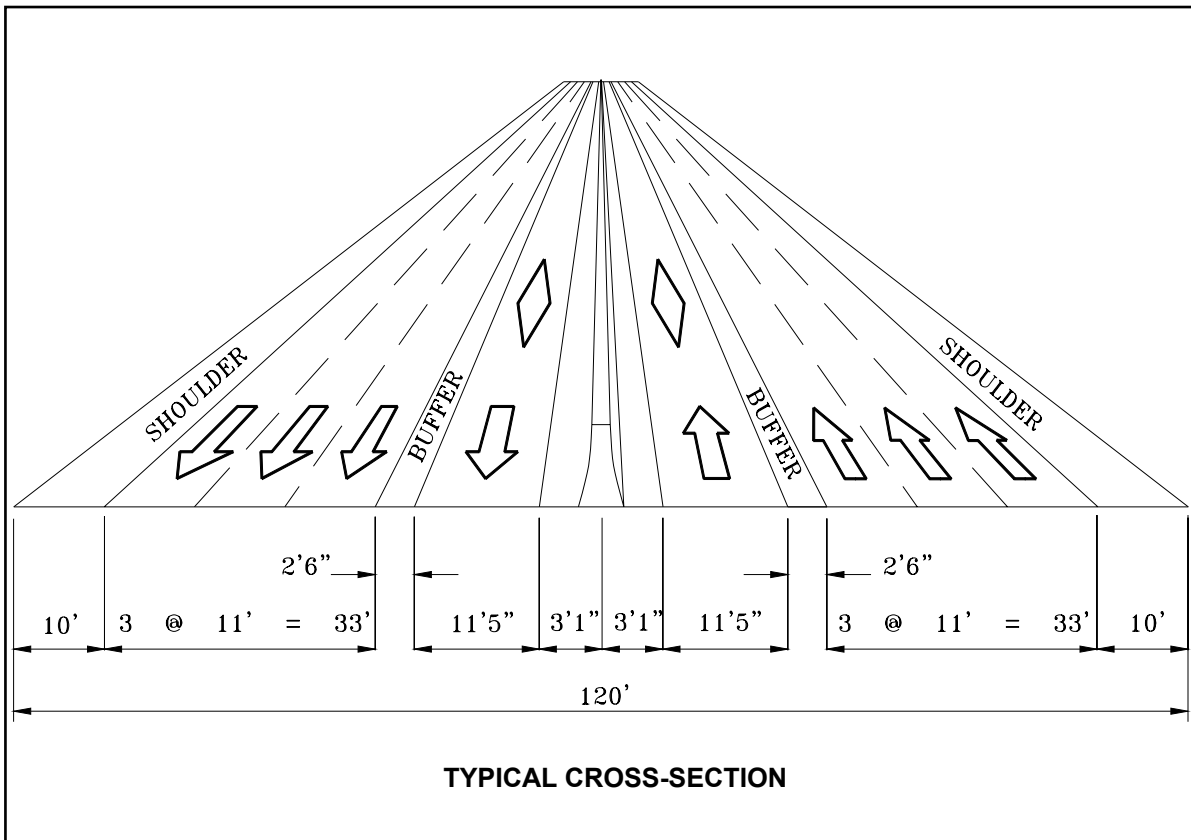
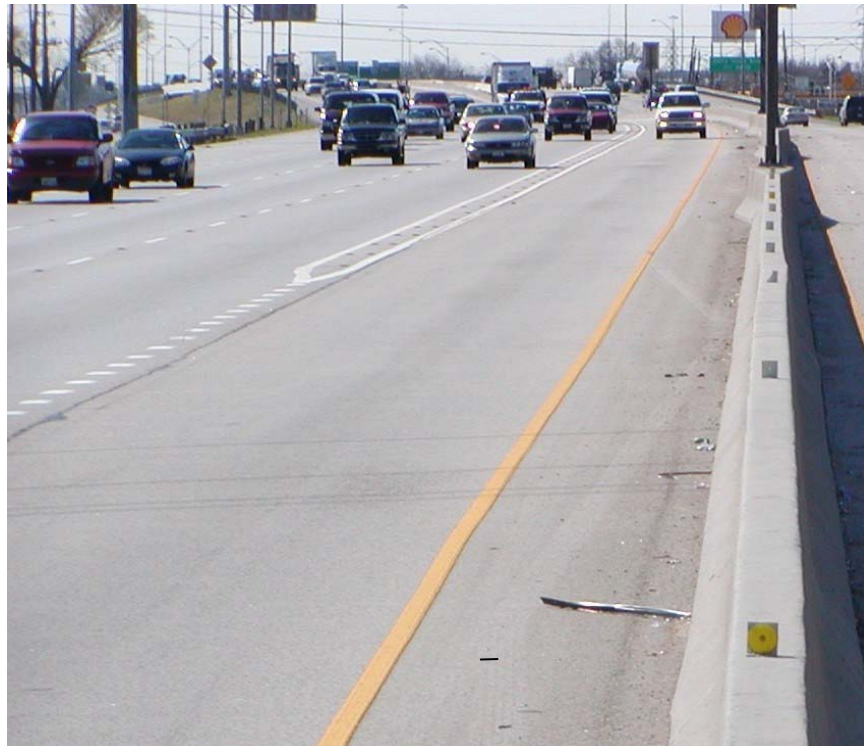
Figure 2. IH-35E North (Stemmons) Freeway HOV Lane (Dallas, Texas).

Note: Intermediate ingress/egress is possible at locations where the painted buffer changes to a single skip stripe as shown in the left side of the photo below.

Table 4 shows higher corridor crash rates for the HOV lane operation period from 1997 to 2000. The injury crash rate average from 1997-2000 is 56 percent higher than the 1990-1994 average. Also, the injury crash rates in the “after” condition are higher for peak travel periods. When looking at individual years, the peak period crash rates in the IH-35E North corridor are shown to be higher than the daily crash rates.

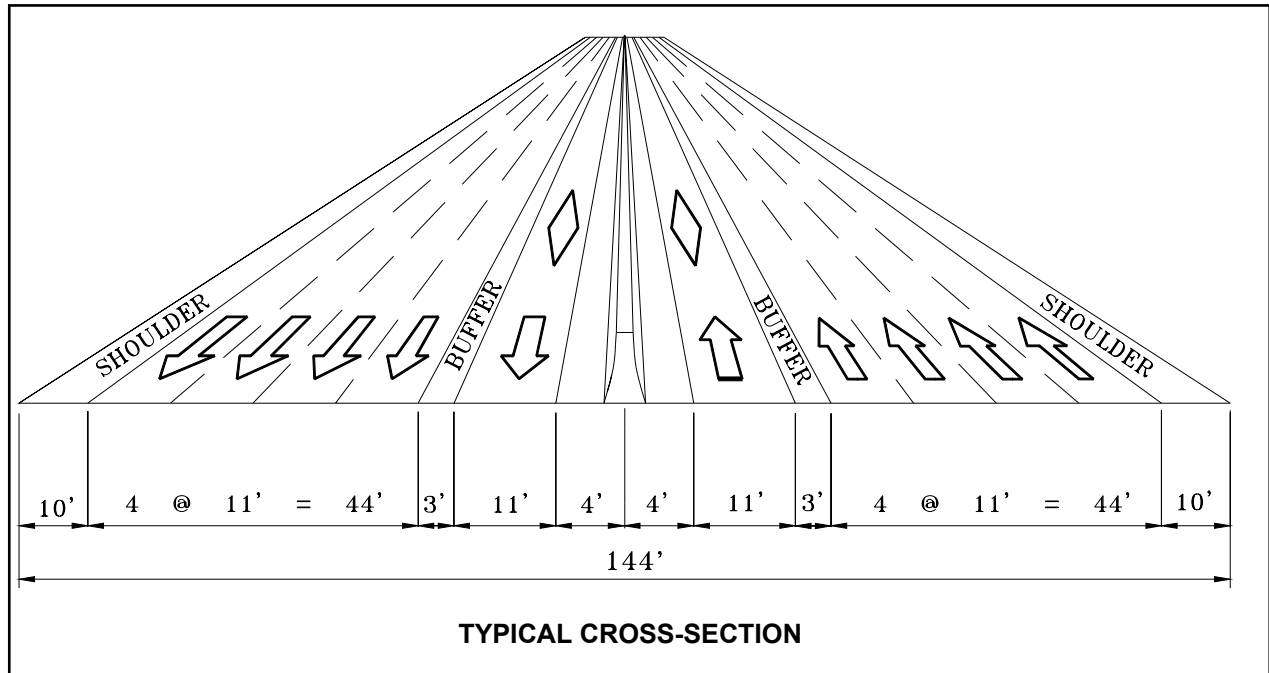
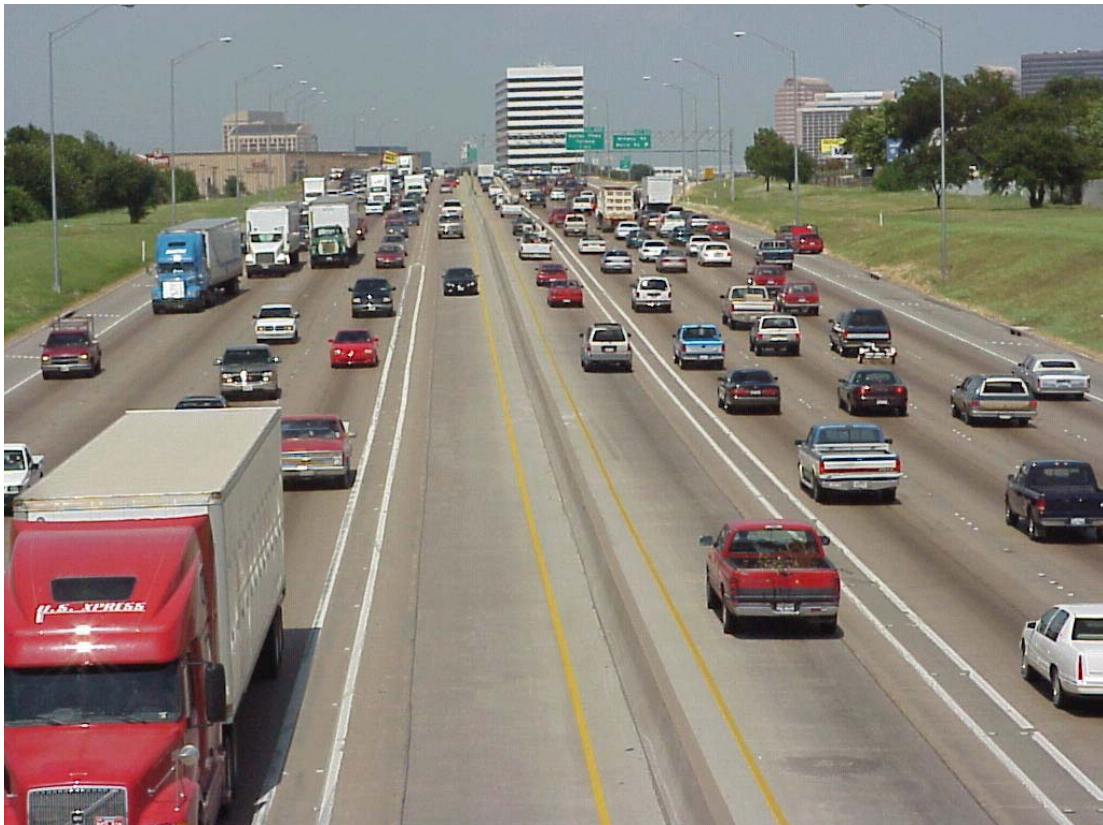
Figure 3. IH-635 (LBJ) Freeway HOV Lane (Dallas, Texas).

Note: Intermediate ingress/egress is possible at locations where the painted buffer changes to a single skip stripe.

Table 5 shows higher corridor crash rates for the HOV lane operation period from 1997 to 2000. The injury crash rate average from 1997-2000 is 41 percent higher than the 1990-1994 average. Also, the crash rates in the “after” condition are higher for peak travel periods. When looking at individual years, the peak period crash rates are shown to be higher than the daily crash in this corridor.

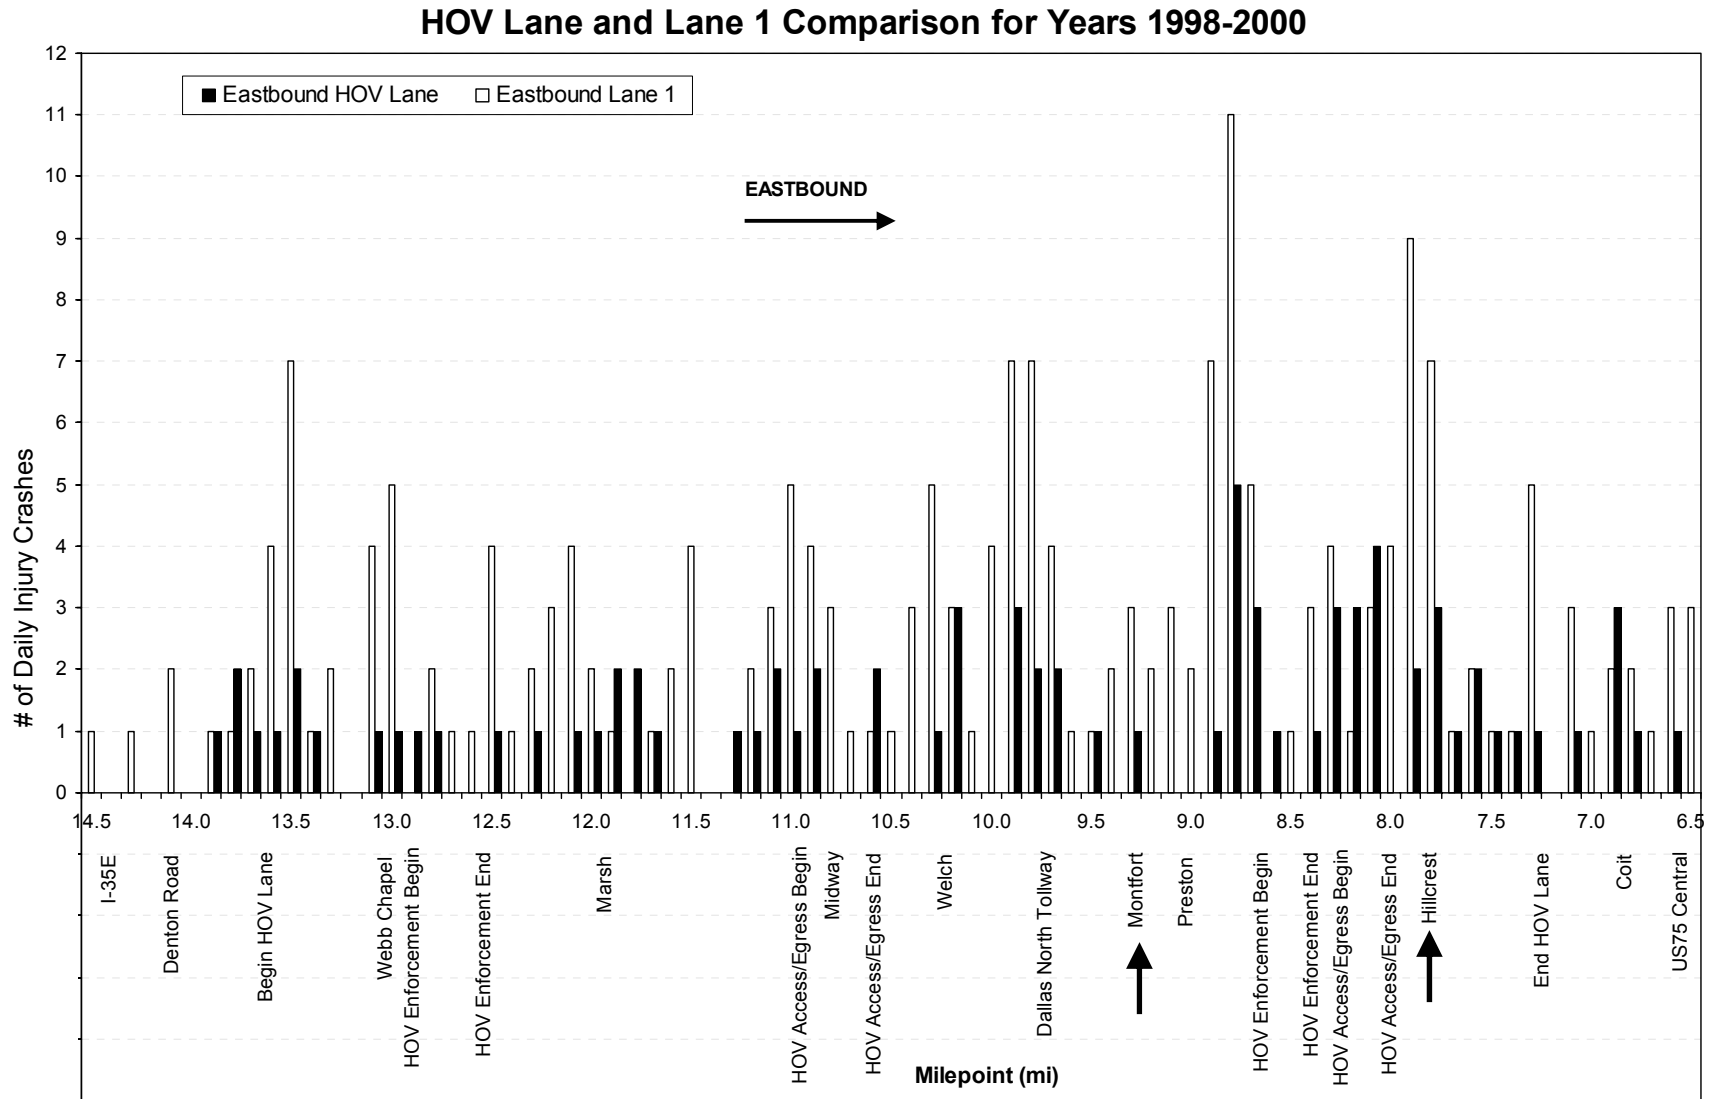
Figure 4. IH-635 (LBJ) Eastbound Injury Crashes by Milepoint – Daily.

Figures 4 and 5 show a concentration of crashes occurring in the area just prior to an enforcement location for the eastbound direction. This concentration is at a location of considerable congestion within the corridor during peak periods. Unstable traffic flow occasionally causes the operating speeds in the eastbound general-purpose lanes to drop to near zero in the area between Montfort Drive and Hillcrest Road based on available speed profile data

The analysis of injury crashes by milepoint in the IH-635 (LBJ) corridor showed crashes occurring throughout the length of the corridor in both the HOV lane and Lane 1. However, the research team noted a high concentration of injury crashes occurring in the area just prior to the HOV lane enforcement area for both directions of the freeway. These areas are locations of high traffic congestion. The speeds in the general-purpose lanes are known to drop very low during peak travel times. As a result, a speed differential exists between the HOV lane and the general-purpose lanes.

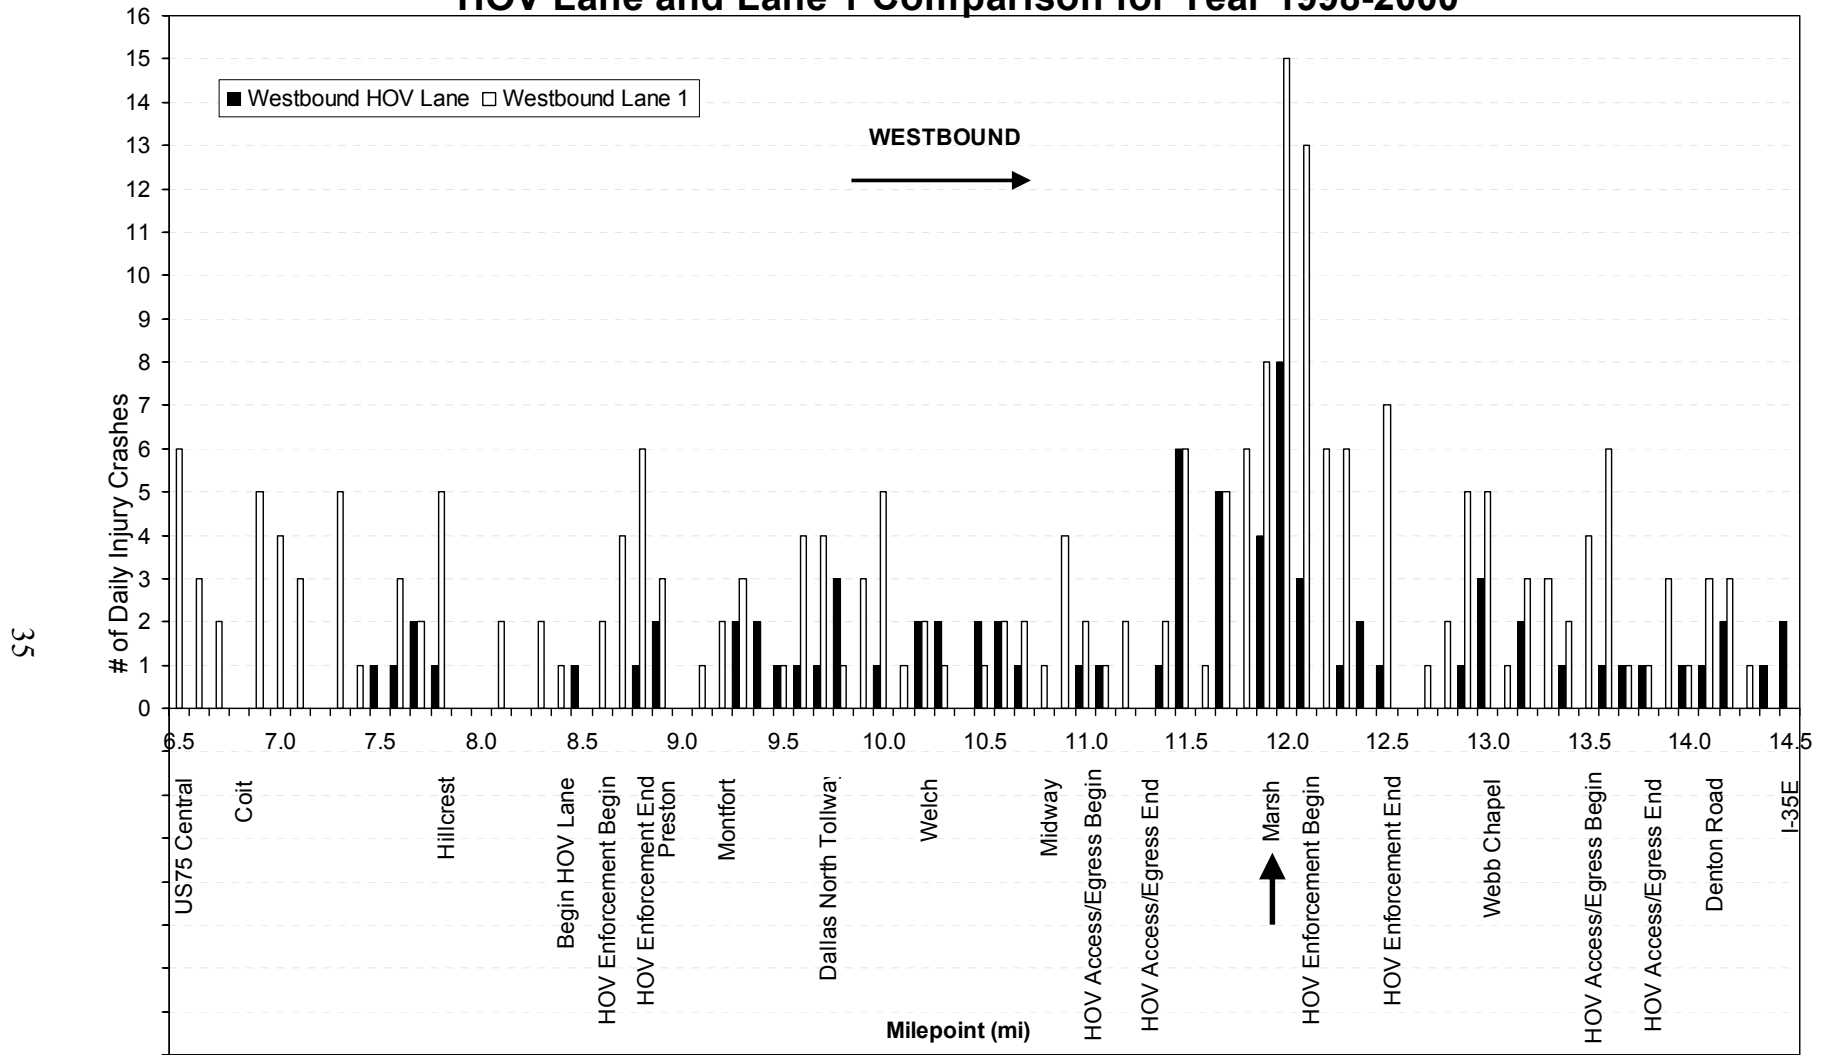
Figure 7. IH-635 (LBJ) Westbound Injury Crashes by Milepoint - Daily.

Figures [7](#) and [8](#) also show a concentration of crashes occurring in the area just prior to an enforcement location for the westbound direction. Congestion and the resulting unstable traffic flow occasionally causes the operating speeds in the westbound general-purpose lanes to drop to near zero in the area near Marsh Lane based on available speed profile data within the corridor as shown in [Figure 9](#). Marsh Lane is indicated by an arrow in each of the figures. [Table 13](#) shows average speed data developed from speed profiles in the corridor which indicates a substantial difference in the peak hour average speed of the HOV lane compared to the general-purpose lanes.

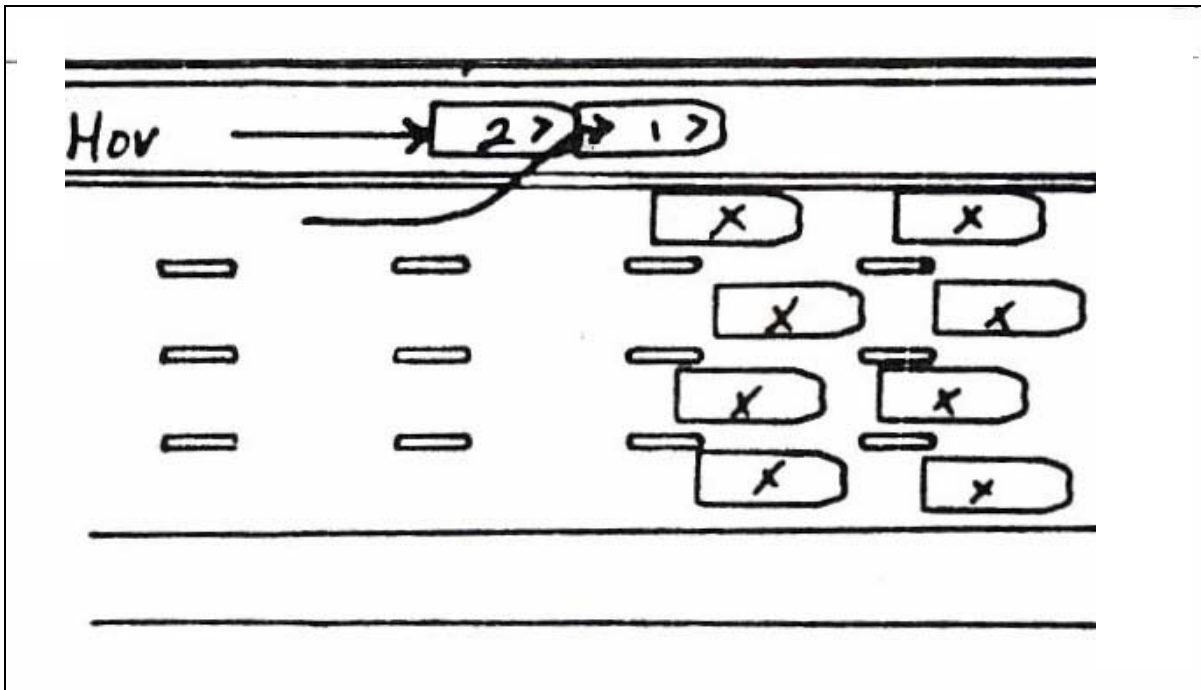
Figure 10. Example of Crash Investigator's Sketch on IH-635.

- Vehicles in Lane 1 are trying to avoid suddenly stopped general-purpose lane traffic by quickly moving into the HOV lane and are involved in a crash with a fast-moving HOV lane vehicle (See typical example in [Figure 10](#)).

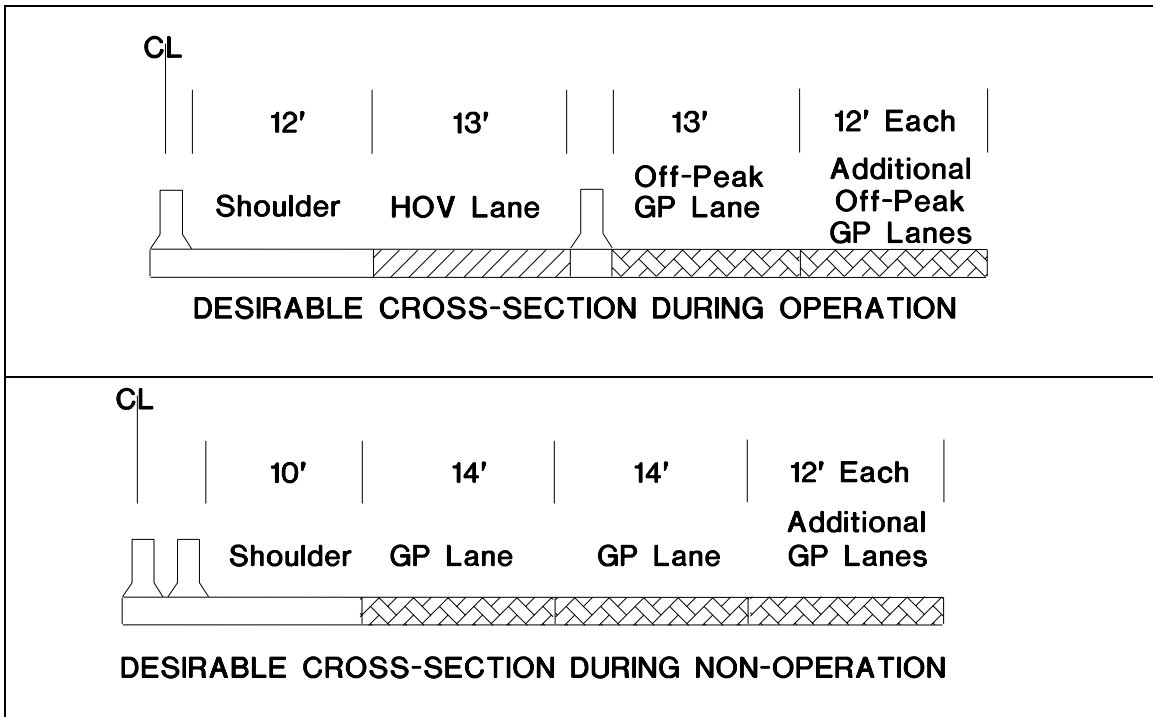
Figure 11. Desirable Cross-Section for Contraflow Moveable Barrier HOV Lanes.

The research team developed the following recommended cross-sections based on the review of electronic crash data for the IH-30 corridor. The corridor characteristics of IH-30 in the Dallas area include limited right-of-way and low traffic in the off-peak direction. [Figure 11](#) shows the desirable cross-section for a contraflow moveable barrier HOV lane. [Figure 12](#) shows the minimum recommended cross-section. The minimum cross-section is currently being used in the IH-30 corridor.

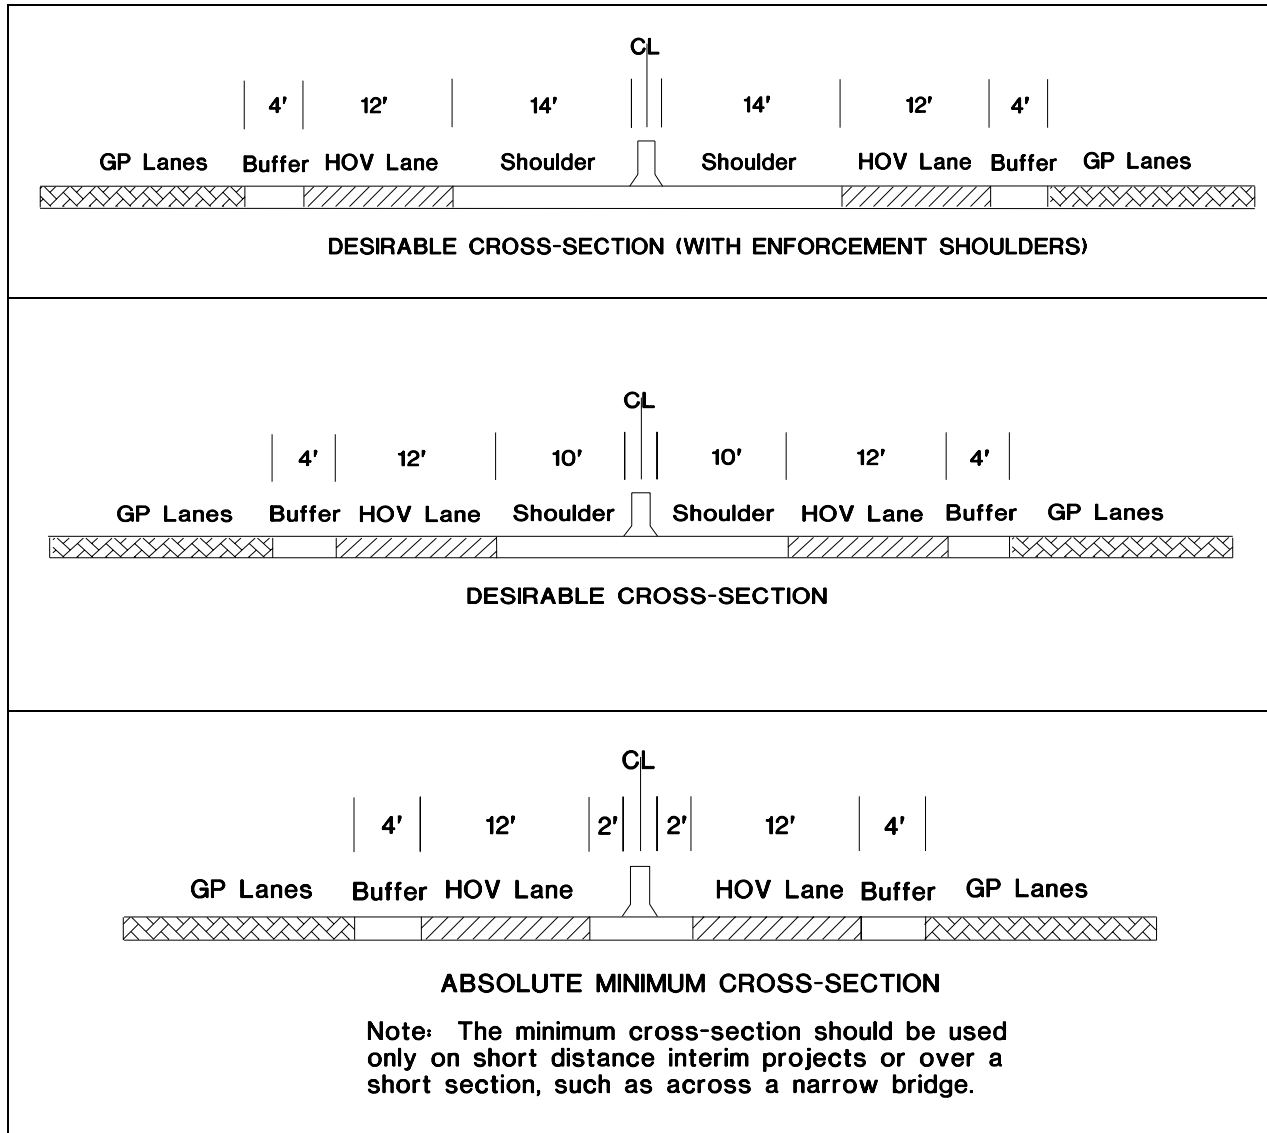
Figure 13. Desirable/Minimum Cross-Section for Buffer-Separated HOV Lanes.

[Figure 13](#) shows recommendations for desirable and minimum cross-sections for future buffer-separated HOV lanes in the Dallas area. The minimum cross-section provides enough room for two 8 feet wide vehicles to be in the HOV lane area (inside shoulder, HOV lane, and painted buffer) of the freeway without encroaching on the general-purpose lanes. This is important because it allows two vehicles with a large speed differential to avoid a collision. As mentioned earlier in the report, vehicles in the Dallas buffer-separated HOV lanes experience difficulties moving to the general-purpose lanes due to the high level of congestion. The gaps simply are not available to do this maneuver at high speeds. With at least the minimum cross-section shown below, HOV lane vehicles can slow or stop if necessary to wait for gaps in the general-purpose lanes and enough room remains for another HOV vehicle to pass.

The minimum cross-section also provides enough room for a slow moving vehicle in the general-purpose lanes to move into the HOV lane and accelerate without completely obstructing the HOV lane or Lane 1. Again, a faster moving vehicle in the HOV lane has a better chance of moving past a slower moving vehicle that has not yet gotten up to speed.
