Evaluation of Best Practices  
in Traffic Operations and Safety:  
Phase I: Flashing LED Stop Sign  
and Optical Speed Bars

E. D. ARNOLD, Jr.  
Associate Principal Research Scientist

| 1. Report No.:<br>FHWA/VTRC 07-R34 | | 2. Government Accession No. | | 3. Recipient's Catalog No. | |

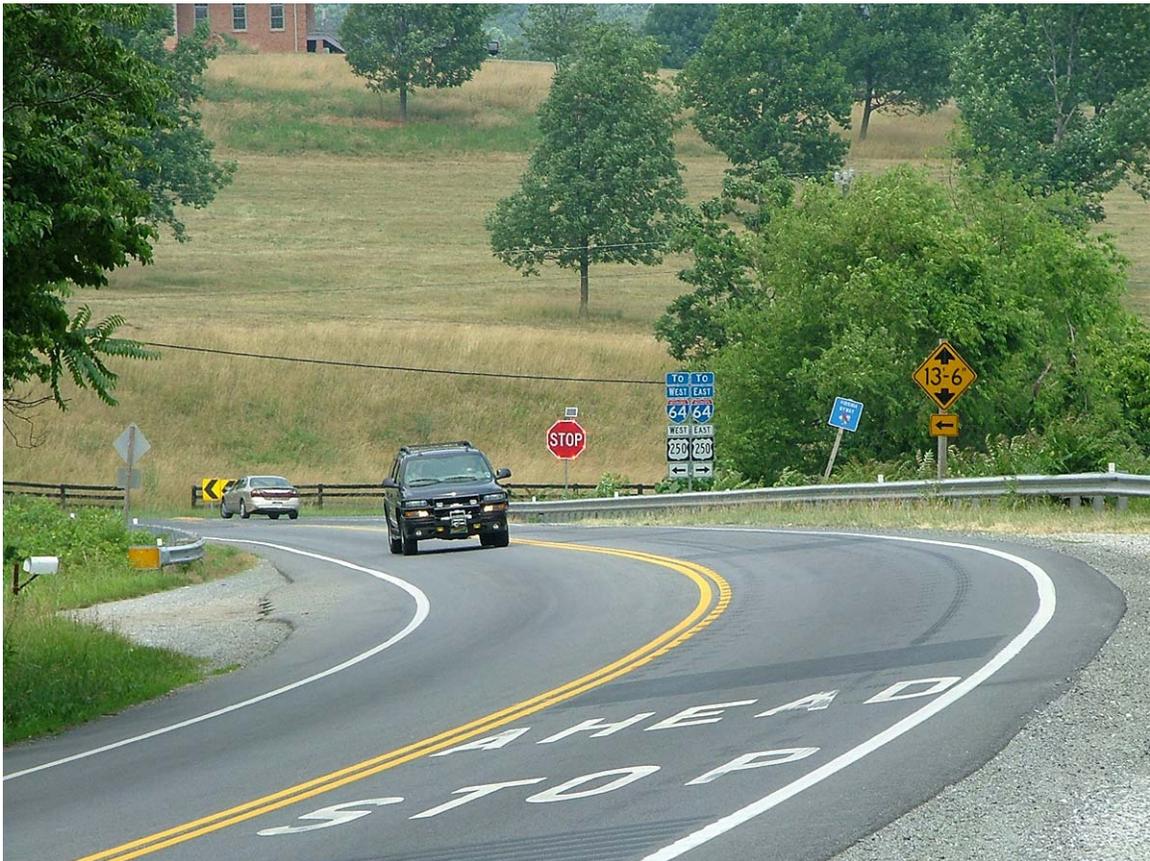
Figure 1. View of Approach to Flashing LED Stop Sign on Route 151

The district's traffic engineers suggested that the higher-than-expected crash rate is caused by several factors on the Route 151 northbound approach. These include a high approach speed, limited sight distance on a horizontal curve, a downgrade into the intersection, and sign clutter at the intersection. A number of countermeasures had been implemented, including the installation of two "stop ahead" signs with accompanying "stop ahead" horizontal pavement markings, rumble strips on both sides of the second horizontal "stop ahead" pavement marking, and a 48-inch oversized stop sign. In addition, VDOT had been considering the installation of flashing beacons on the stop sign and a right-turn lane on the Route 151 approach. These plans were postponed pending an evaluation of the flashing LED stop sign.

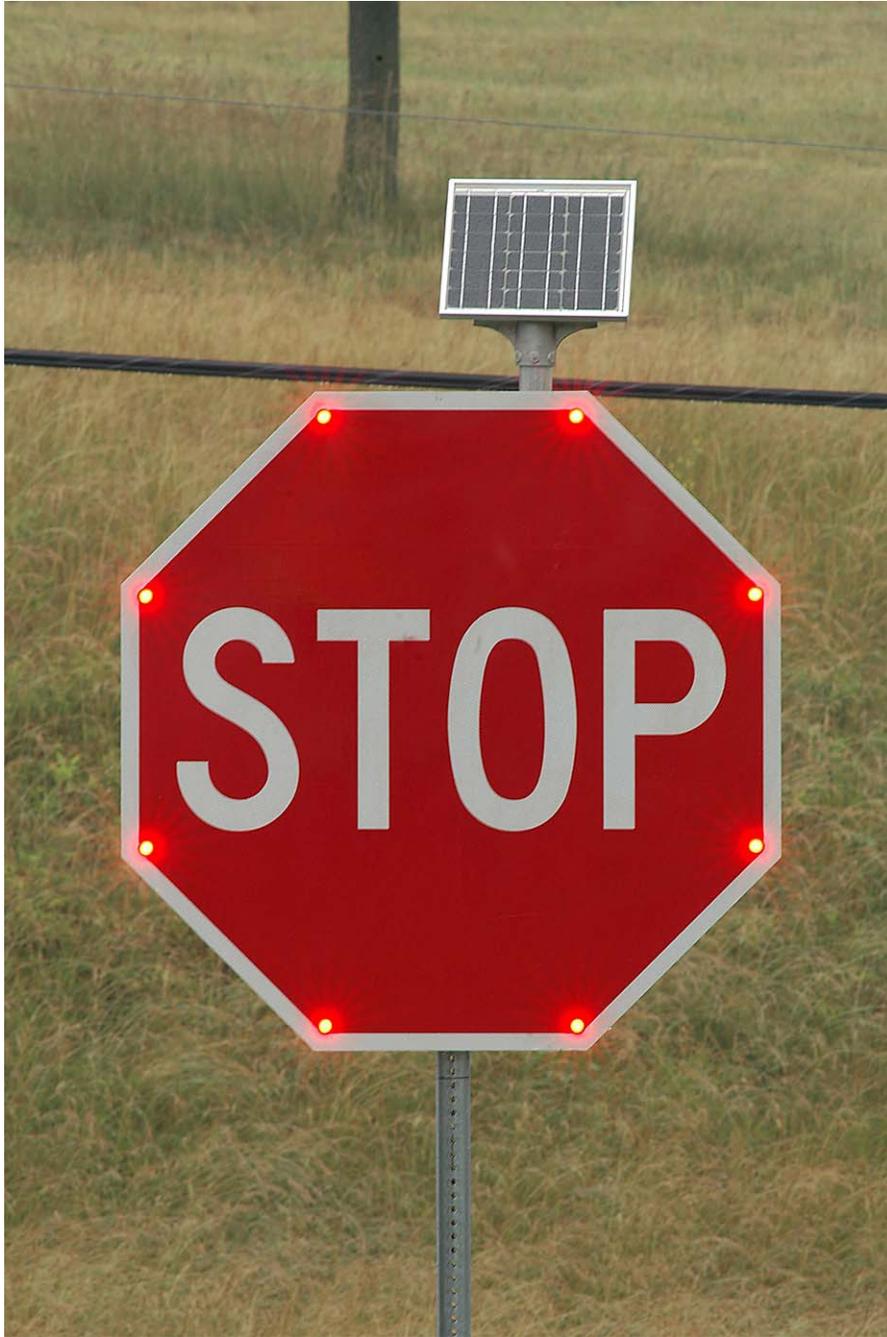
**Figure 2. Flashing LED Stop Sign Installed on Route 151**

VDOT crews installed a 48-inch flashing LED stop sign at the intersection on June 14, 2006. The sign was a solar Day-Viz™ BlinkerStop™ sign donated to VDOT by Traffic & Parking Control Company (TAPCO) for evaluation. The unit contains red 7/8-inch-diameter LEDs in each of the eight corners of the sign. A solar panel, 13.5 by 15 inches, supplies a 4.8-volt NiMH 6-inch battery pack. The sheeting is 3M VIP/DG3 diamond grade or similar prismatic sheeting. The LEDs are wired to turn on and off simultaneously and flash continuously at a rate of 1 flash per second. There is automatic dimming for reduced night brightness. Figures 1 and 2 show the installation. The 48-inch sign sells for \$1,860. The standard 36-inch and 30-inch Day-Viz™ BlinkerStop™ signs sell for \$1,640 and \$1,600, respectively. TAPCO offers an approximate 25 percent discount to state departments of transportation (DOTs). Costs associated with installation included \$175 for a post and anchor and \$650 for labor, equipment, and traffic control.

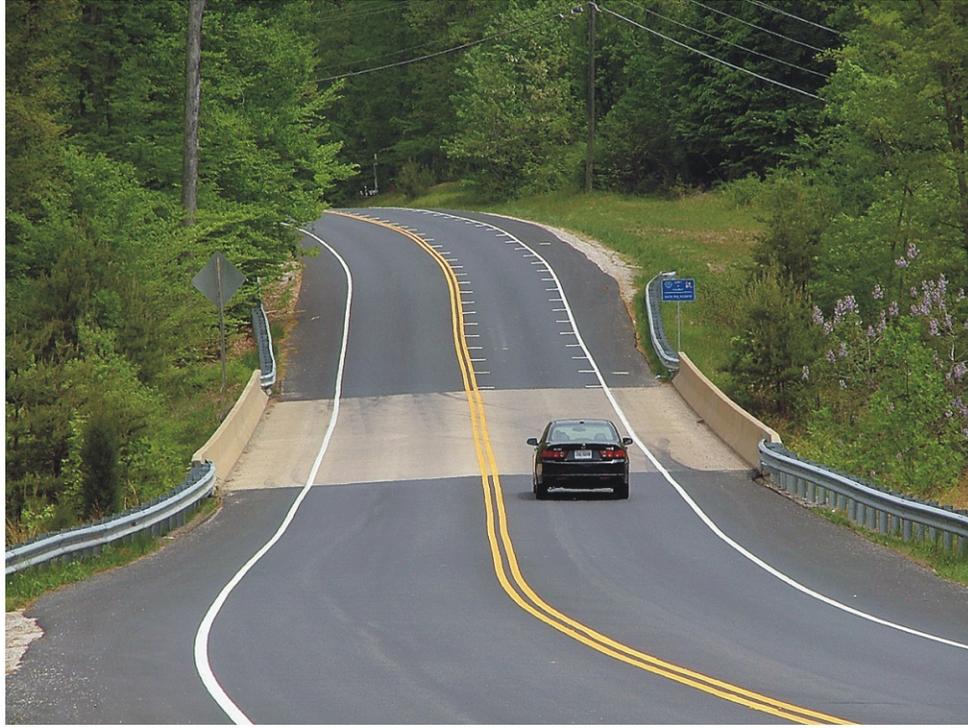
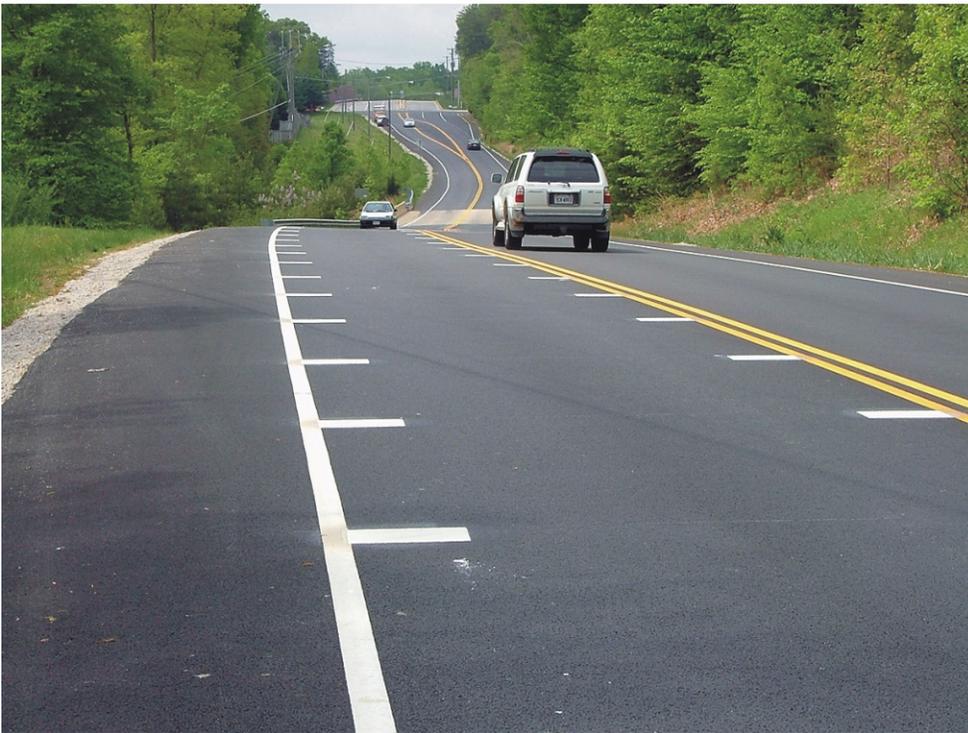
**Figure 3. Optical Speed Bars on South End of Lee Chapel Road Installation. *Top:* View Looking North. *Bottom:* View Looking South.**

VDOT crews installed optical speed bars on May 3, 2006, on the approach lanes at the north and south ends of the hazardous section to reduce the speeds of vehicles entering the section. A pattern used at a site in New York (see Appendix B) was used for installing the bars. It consisted of 31 bars over a length of 530 feet. Because of the intersection of Lee Chapel Road with a local residential street, only 448 feet were available for the installation of the pattern on the north end of the section. The spacing between the bars varied from 24 to 12 feet. A field review prior to installation located where the patterns were to begin on both approaches to the hazardous section.

VDOT traffic engineers were concerned about the visual and aesthetic effects of installing bars completely across the travel lanes. There was also the potential for motorist confusion in the vicinity of the painted median on the north approach. As a consequence, the optical speed bars consisted of thermoplastic pavement markings, 18 inches by 12 inches, installed on the approach lane to the hazardous area and extending from both the edge line and the centerline. Figures 3 and 4 show the installed bars at each end of the section. Installation was completed in about half a day and cost approximately \$1,800, which included labor, material, and equipment.

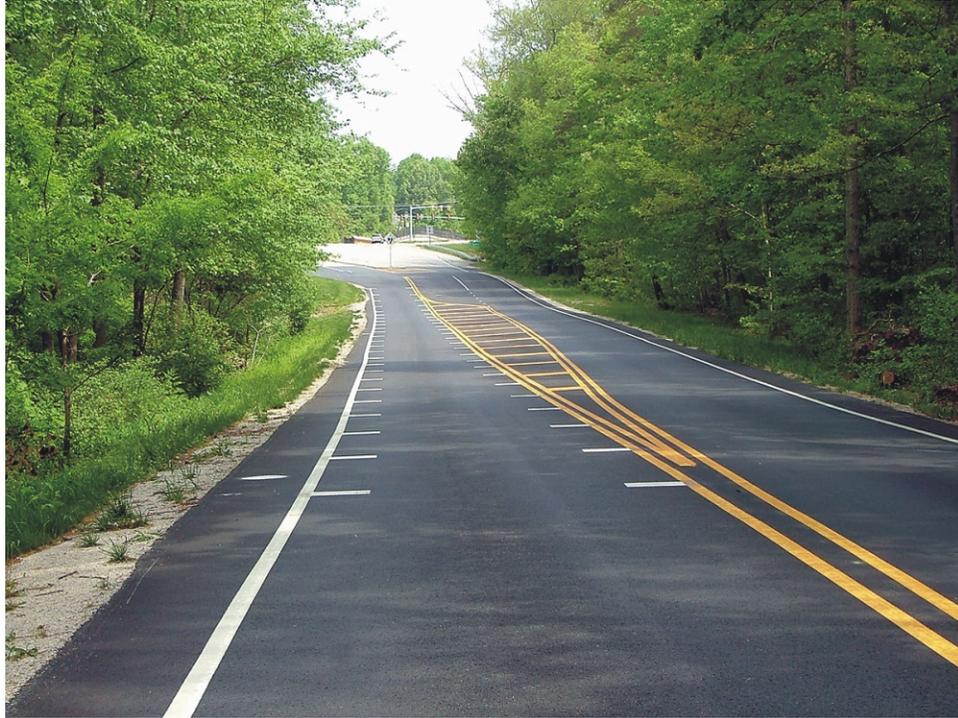
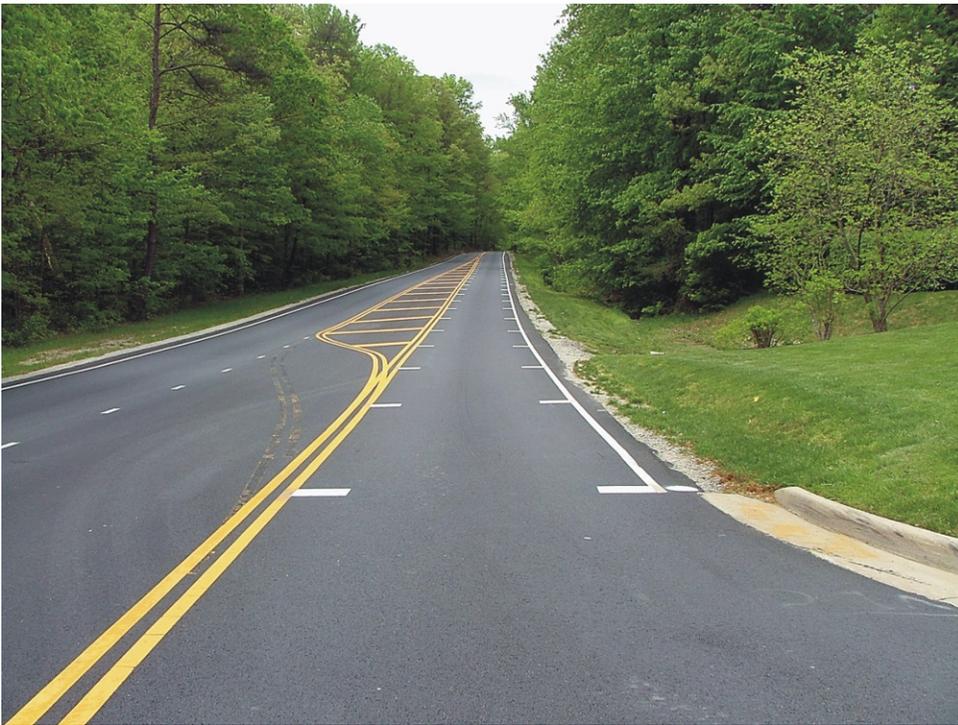
**Figure 4. Optical Speed Bars on North End of Lee Chapel Road Installation. *Top:* View Looking North. *Bottom:* View Looking South.**

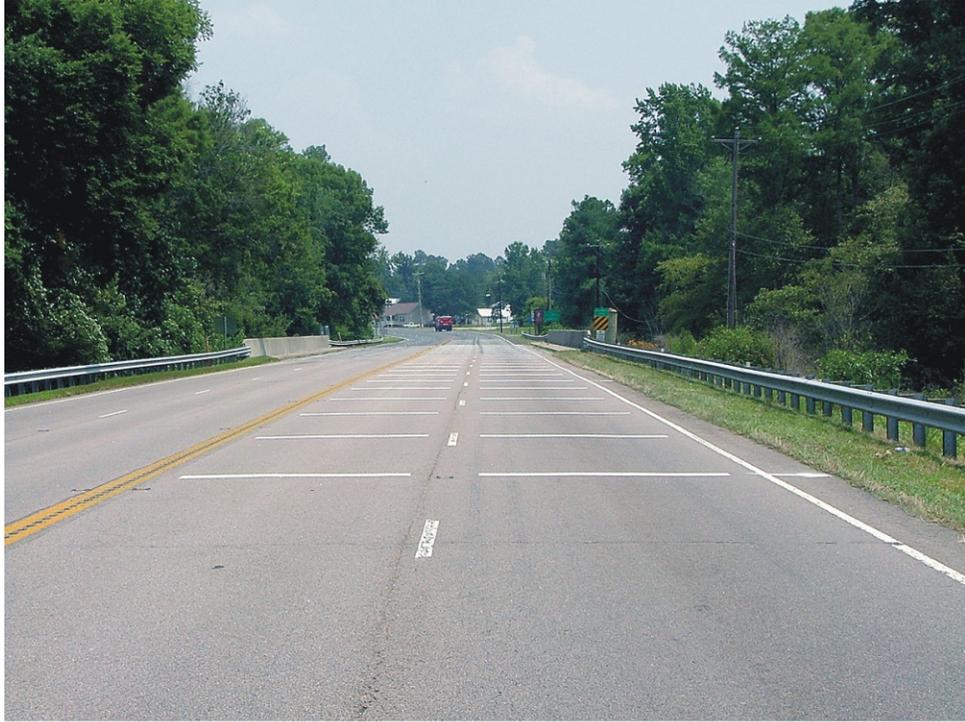
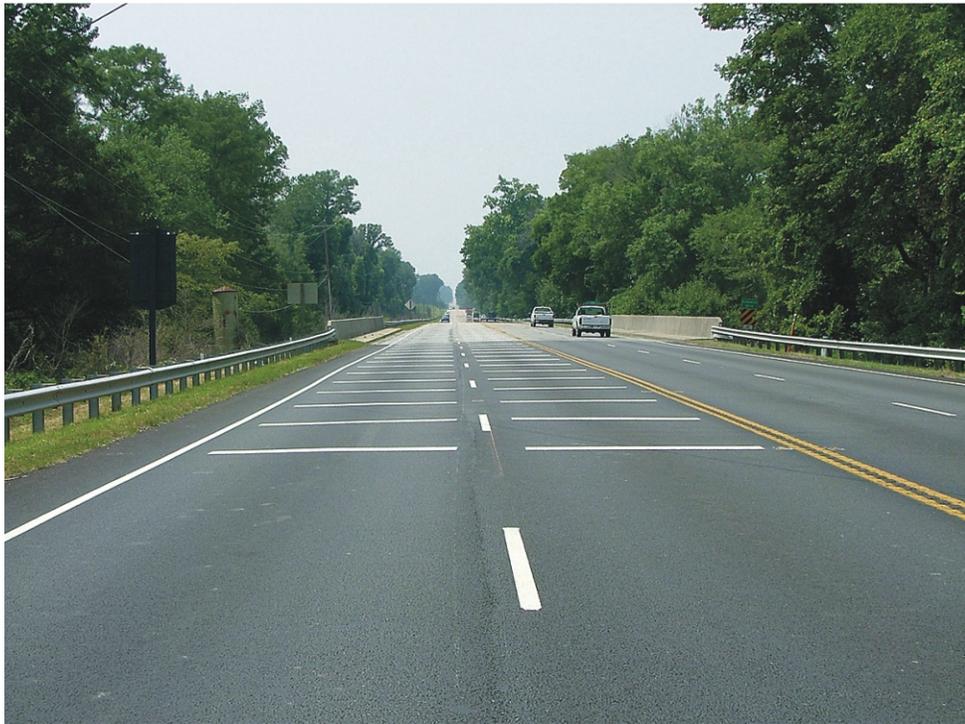
**Figure 5. Optical Speed Bars on Route 460, West Side of Zuni. *Top*, View Looking East. *Bottom*, View Looking West.**

2006. A pattern used at a site in Texas (see Appendix C) was used for the installation. It consisted of 32 bars in the westbound direction and 40 bars in the eastbound direction. The eight additional bars in the eastbound direction were installed in order to reduce speeds to 40 mph at the intersection with Route 644 because of its aforementioned poor sight distance to the west. The spacing between the bars varied from 24 to 17 feet westbound and from 24 to 15 feet eastbound.

The bars were 12 inches wide and were placed 1 foot off the edge line, skip centerline, and solid yellow centerline separating the east and westbound lanes. Lanes are approximately 10.5 feet through the section; thus, the bars are approximately 8.5 feet long. Figures 5 and 6 show the installed bars on each approach to Zuni. The bars were installed in an estimated total time of 9 to 10 hours and with an estimated cost for labor and materials of \$15,000.

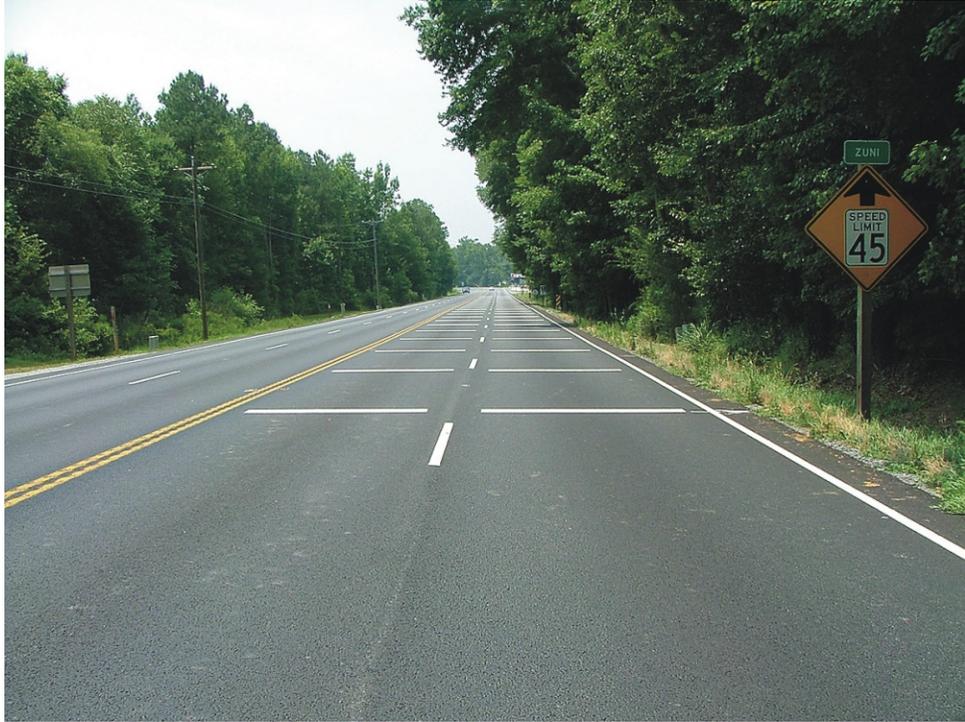
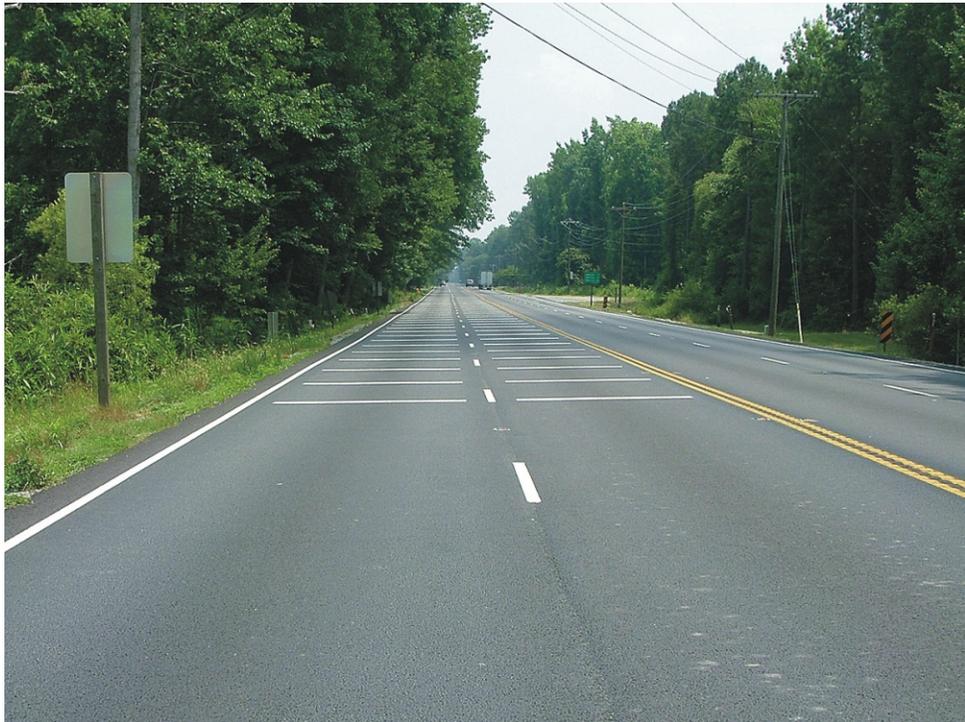
**Figure 6. Optical Speed Bars on Route 460, East Side of Zuni. *Top*, View Looking West. *Bottom*, View Looking East.**
